PROJECT			
ELECTROLUX HOME PRODUCTS JEFFERSON, IOWA			
TITLE			
PROPOSED MONITORING WELL LOCATIONS			
PROJECT No.	103-87305	FILE No.	10387305K001 Well Locations
DESIGN	JSP	09/15/2015	SCALE AS SHOWN
CADD	CDS	09/15/2015	FIGURE
CHECK			
REVIEW			
			1

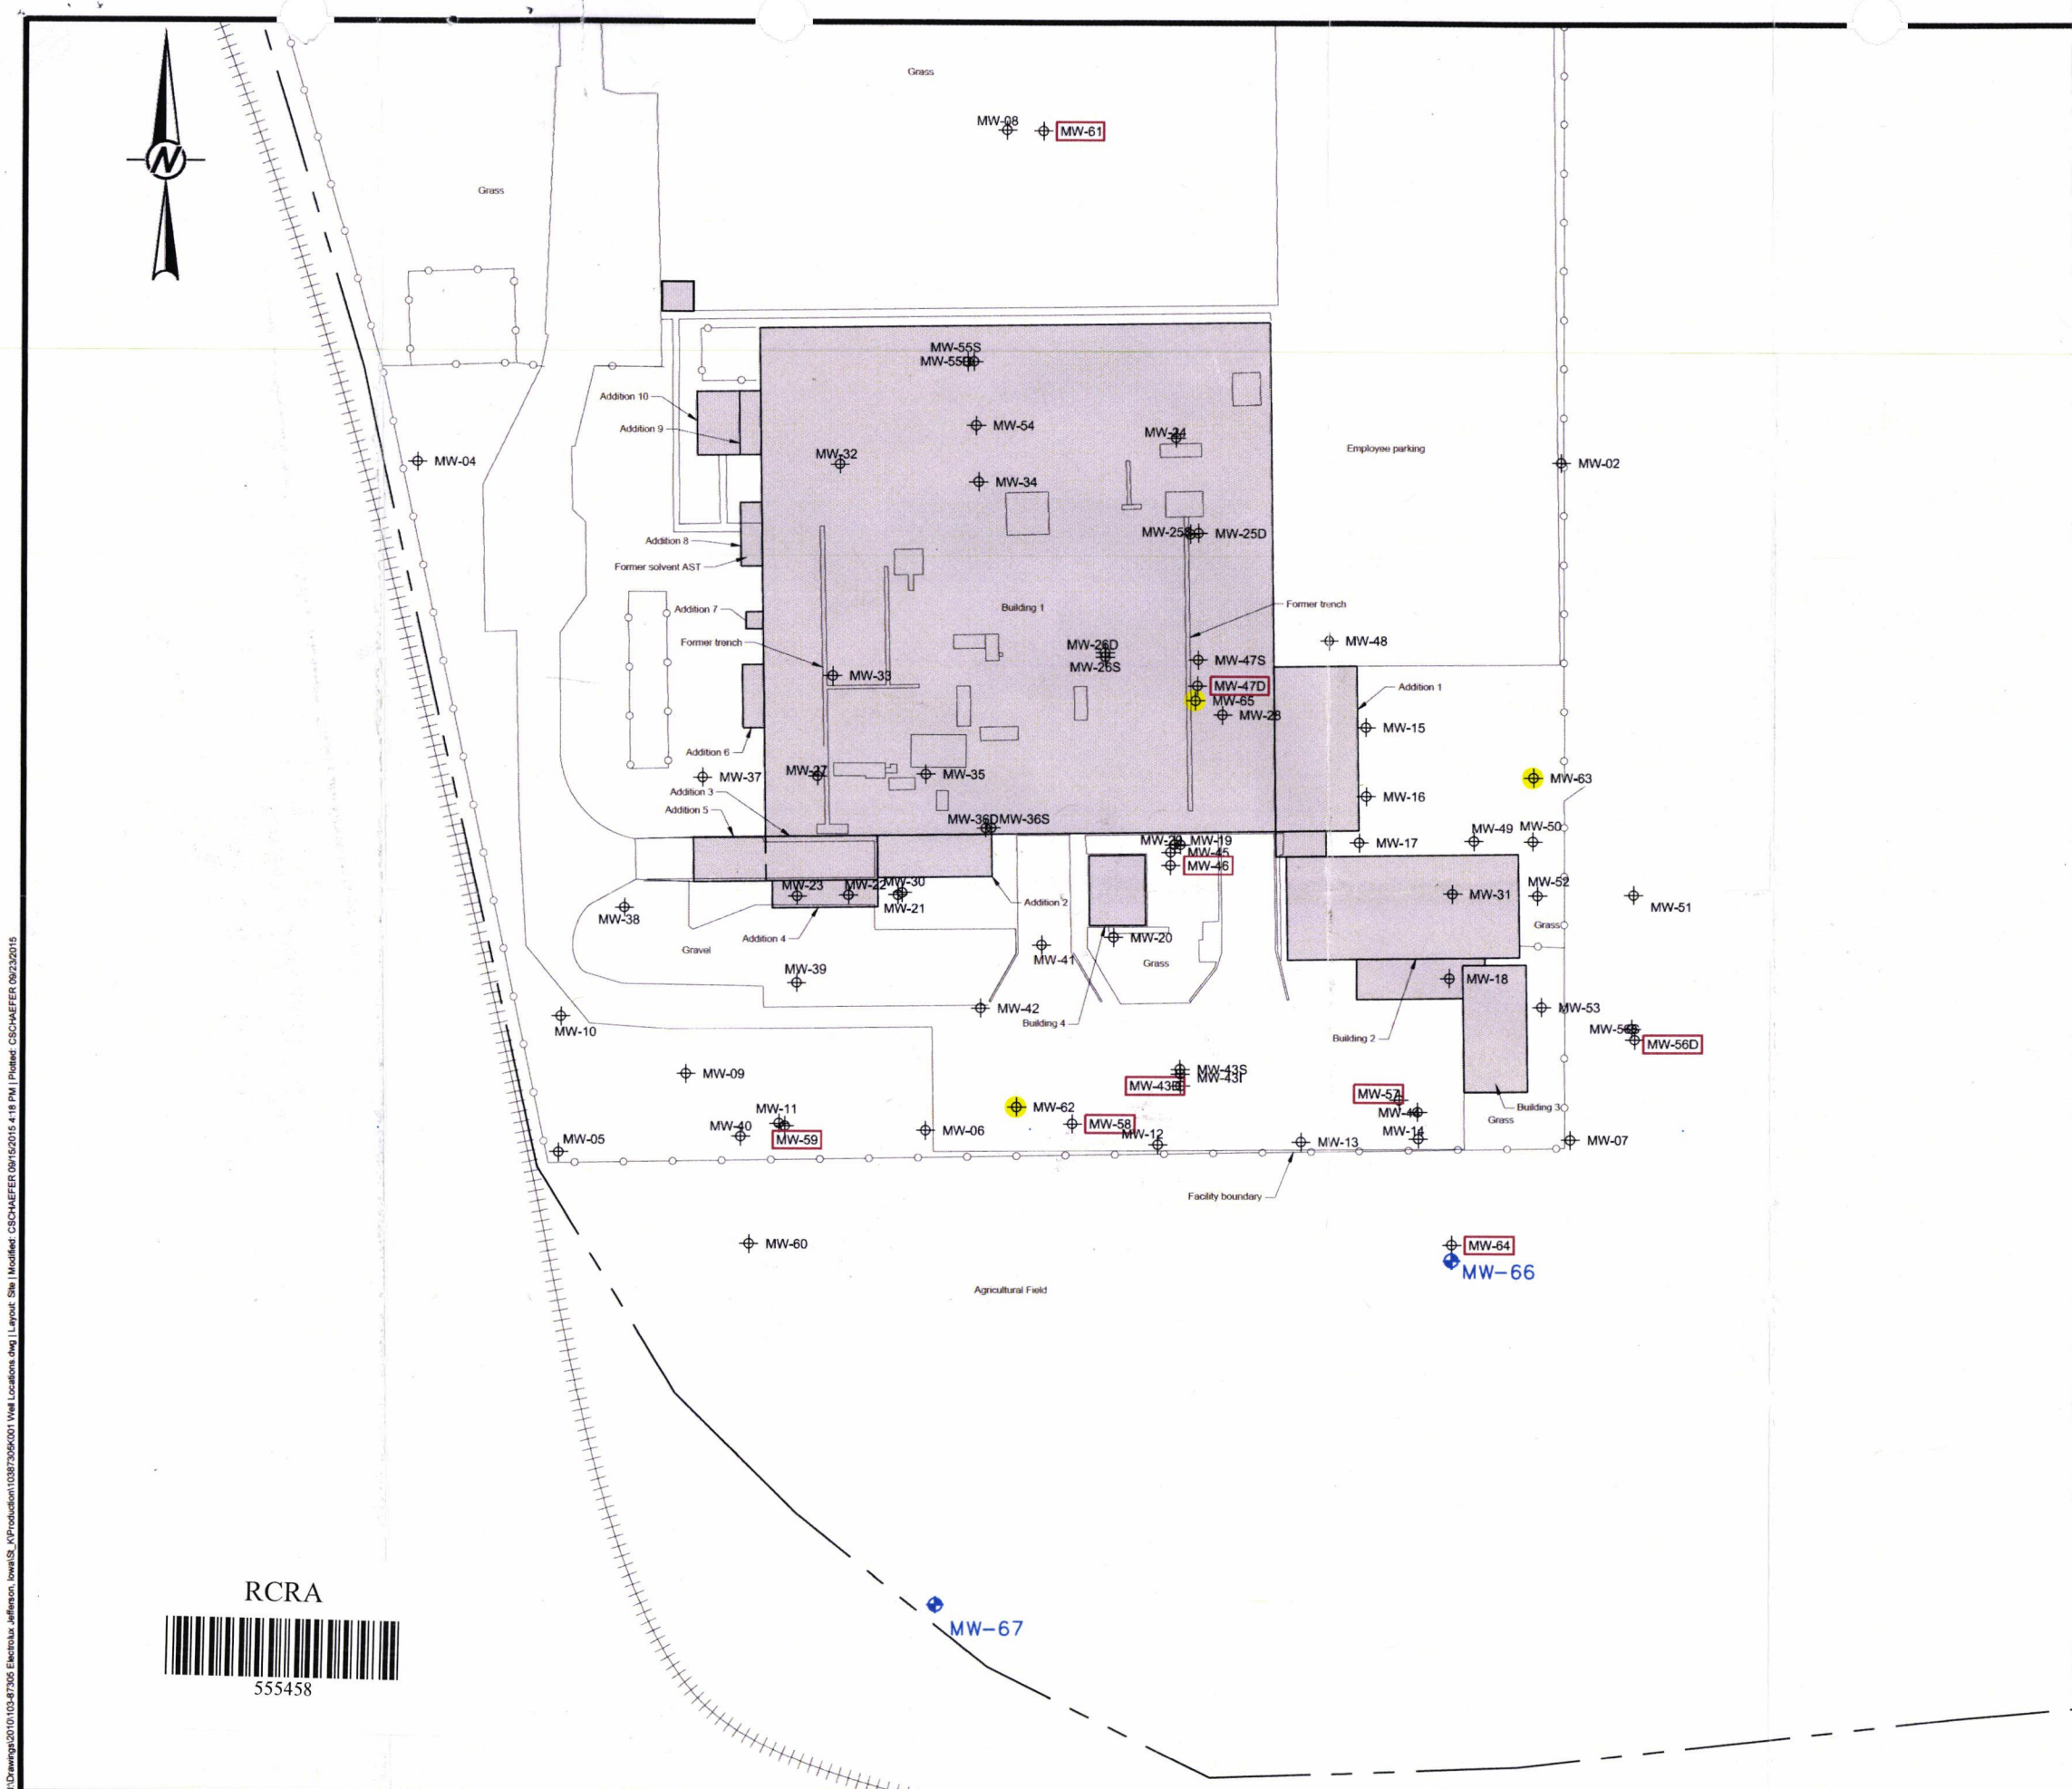
This figure shows the former buildings and existing and proposed monitoring well locations at the former Electrolux Home Products facility in Jefferson, Iowa. The features shown on the concrete slab are locations of former concrete-lined floor pits and drains.
